# Exemplu de mediu de corozivitate categoria C3

# Produse Zincate conform SR EN 1461:2022

# Exemple de Proiecte de bună practică Zincarea Termică

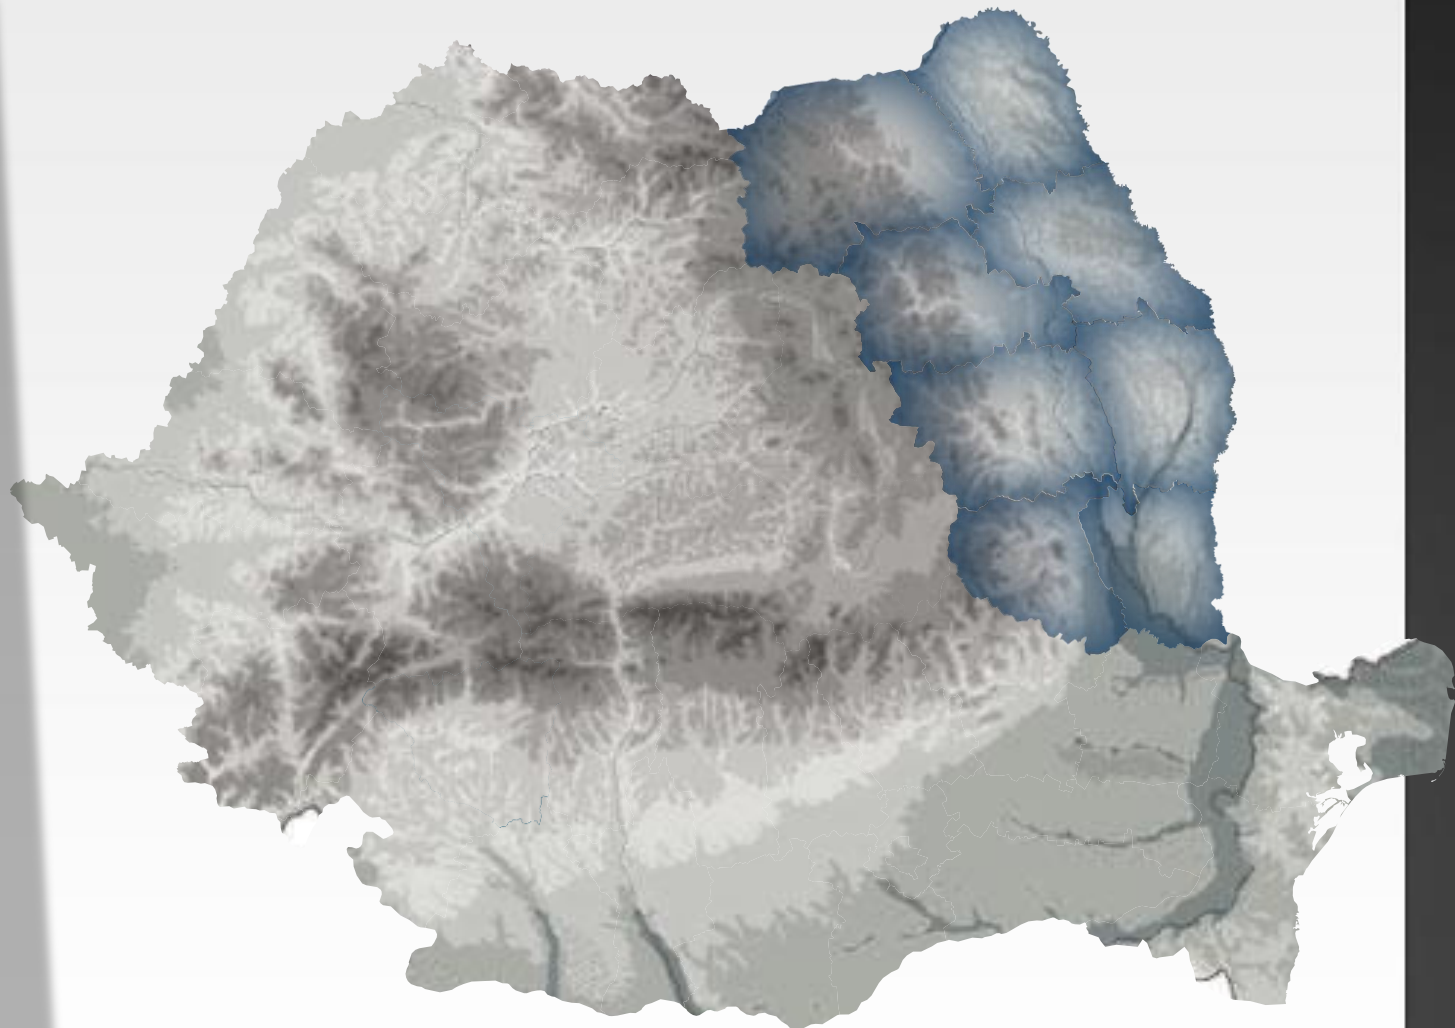
Estimated Steel Mass Loss: 24876  $\mu\text{g}/\text{cm}^2/\text{a}$

Estimated ISO Corrosivity Category: C3

*24876  $\mu\text{g}/\text{cm}^2/\text{an}$  din masa oțelului ceea ce este echivalentul a **248.76  $\text{g}/\text{m}^2$**  din masa otelului, respectiv **31 de  $\mu/\text{an}$** . Pentru mediul de corozivitate **C3** conform SR EN ISO 1461:2022 cu între **0,7-2  $\mu$  de zinc/an**, zincarea termică protejeaza pierderea a **31  $\mu$  de oțel/an***
